## AIRCRAFT GUN ICING EVALUATION

## TECHNICAL REPORT

AIRCRAFT & AIR DEFENSE WEAPONS SYSTEMS DIRECTORATE

R-TR-77-021 ✓

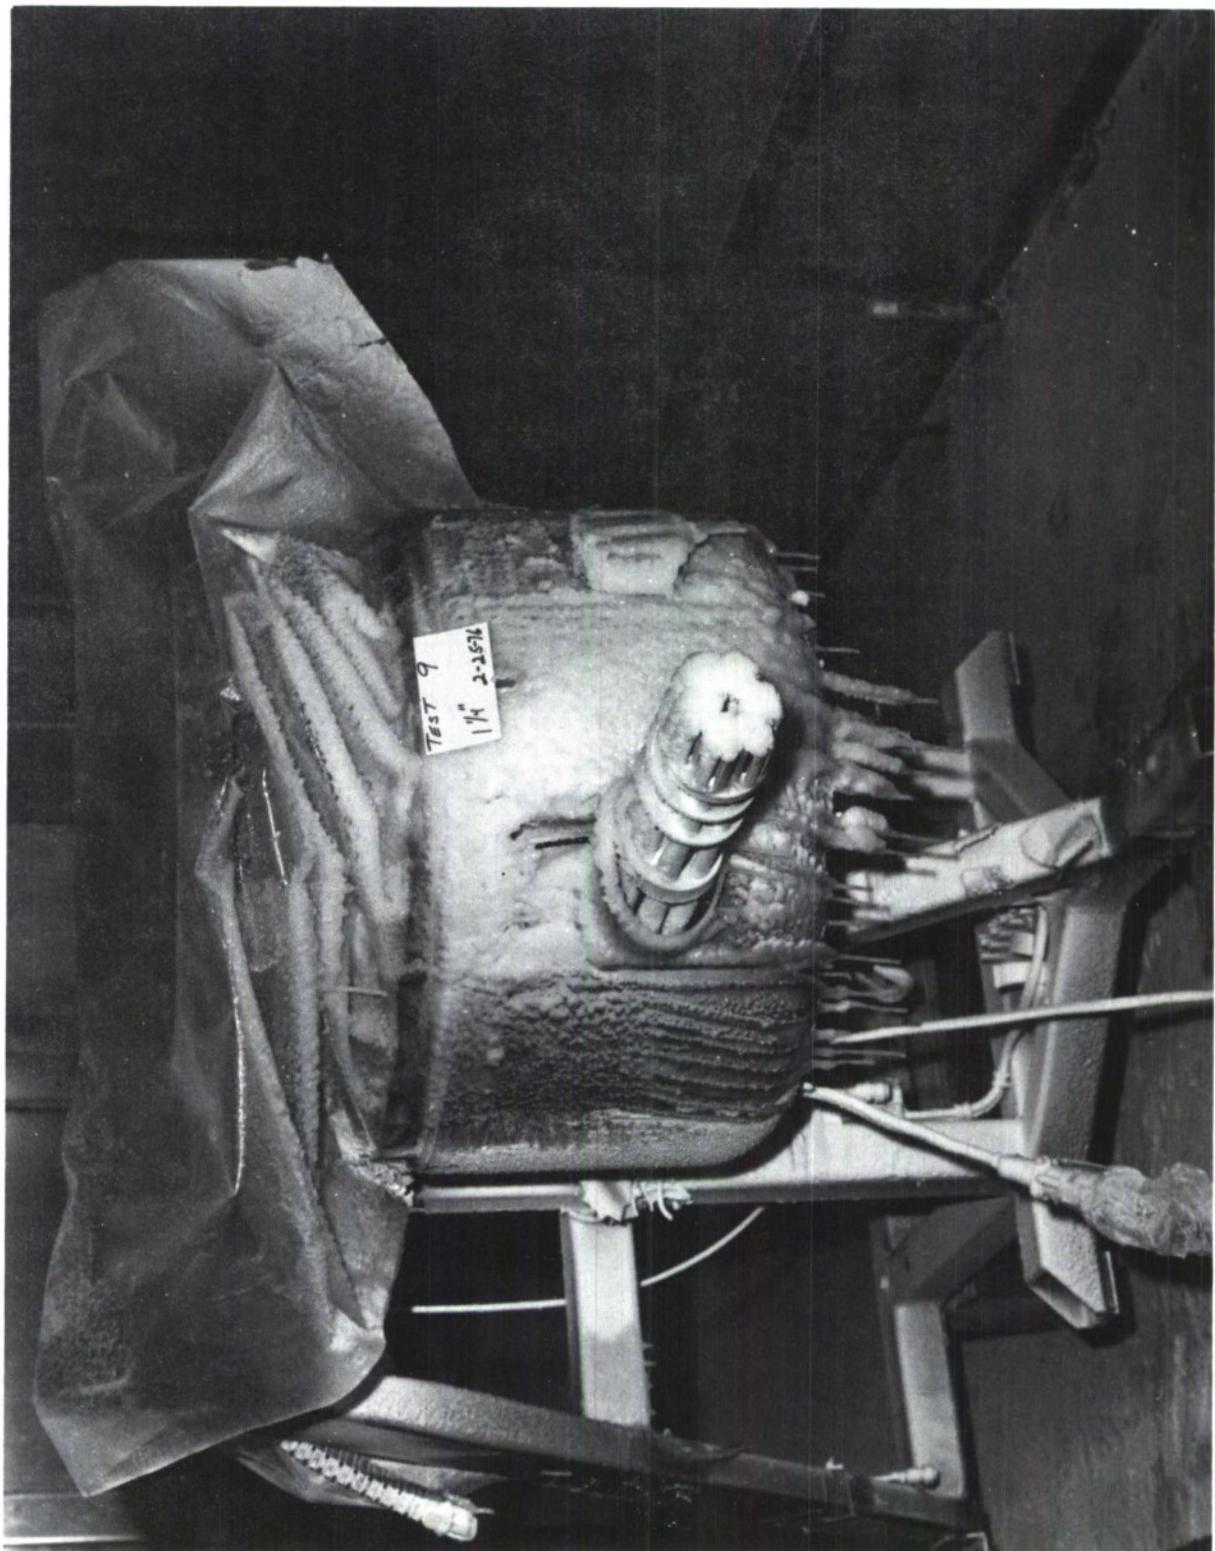
Fig. 8, M134 GUN WITHOUT FLASH SUPPRESSOR, COATED WITH 1 1/4 INCH ICE
